Concrete Repair and Protection

Social Security Offices Brun House, Burnley

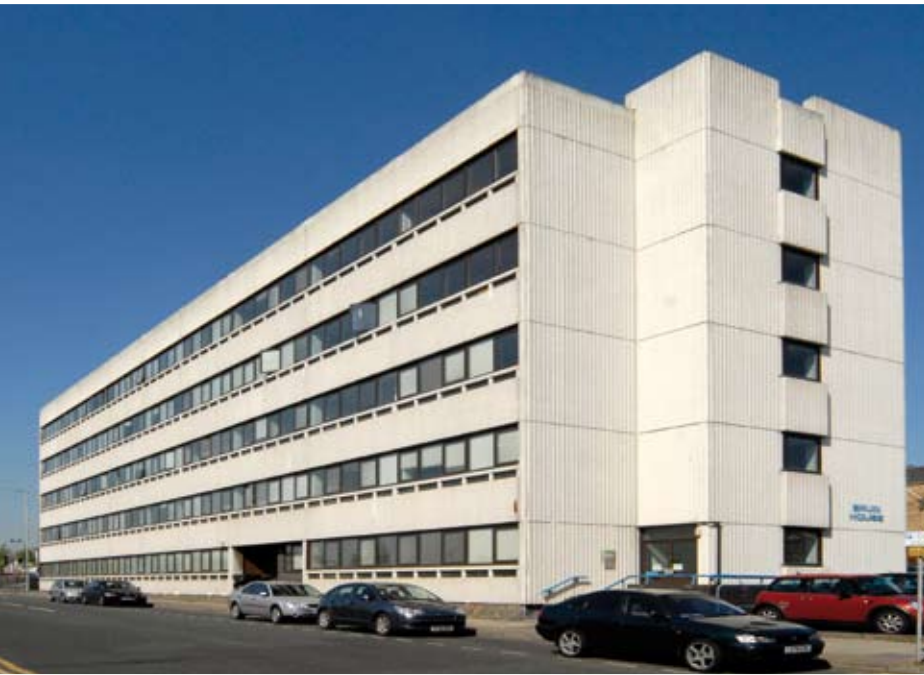
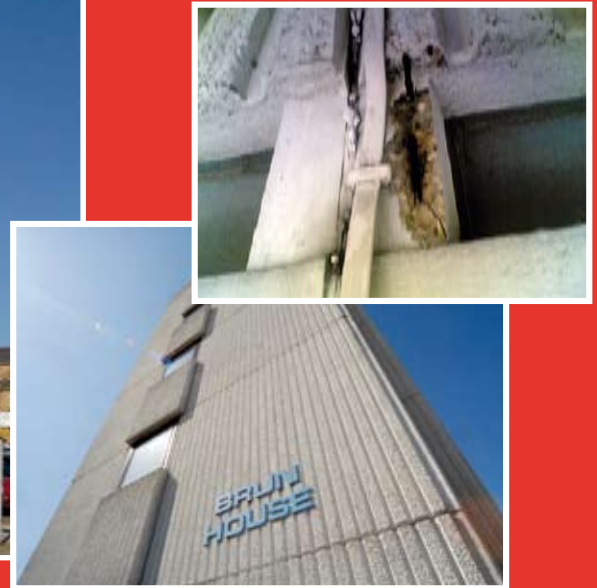
Brun House in Burnley, is a reinforced concrete framed building with brick and rendered infill panels around conventional glazing in its facade. The building houses the busy Social Security offices of the local DHSS for the area.

As usual, this survey consisted of a detailed report with marked up drawings for all elevations and surfaces, plus photographic records and hammer testing results. This resulted in a schedule for the extent of the individual repairs to the concrete, which was spalling over corroding steel reinforcement. In combination with laboratory analysis, this also clearly showed the root cause of the problems to be carbonation of the unprotected

concrete. This was particularly evident in areas with insufficient concrete cover, or honeycombing due to poor compaction, i.e. itself due to poor workmanship originally. This loss of alkalinity was now allowing the steel in these areas to corrode, causing spalling of the cover concrete.

Problem: Inadequate concrete cover to steel reinforcement

Result: Concrete cracking and spalling over corroded steel

SUKR provided a full remedial specification, including a complete Sika concrete repair and protection system. This was designed to repair the damage and importantly, prevent its recurrence in future. It also included full budget costings and access proposals, to enable the client to schedule their ongoing maintenance programme simultaneously.

Solution: Complete concrete repair and protection system
